Kissing Cartilage Lesions of the Knee Caused by a Bioabsorbable Meniscal Repair Device

A Case Report

Robert F. LaPrade,* MD, PhD, and Nicholas J. Wills, MD

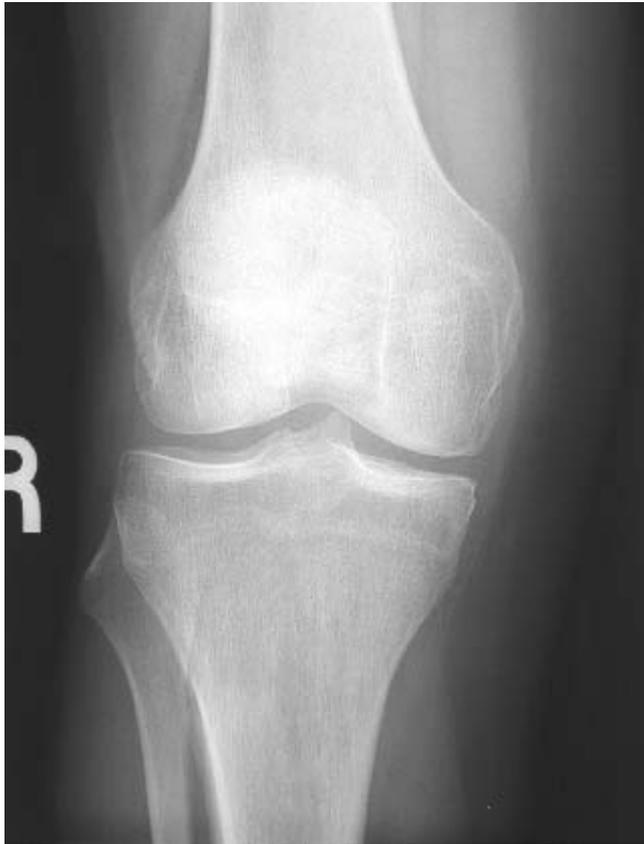
Figure 1. Original normal AP radiograph (right knee).

The patient came to our institution complaining of continued right knee medial joint-line pain and swelling. Radiographs of the knee at that time were normal (Figure 1) with no joint space narrowing, osteophyte formation, or subchondral sclerosis. The patient was given nonsteroidal anti-inflammatory medications and enrolled in physical therapy. He returned 1 month later with complaints of continued medial knee pain and swelling. At that time, our differential diagnosis included synovitis from a reaction to the bioabsorbable implants or a possible re-tear of the previously repaired meniscus. An MRI with intra-articular gadolinium was obtained that revealed a full-thickness groove in the sagittal plane in the articular cartilage of the medial femoral condyle (Figure 2).

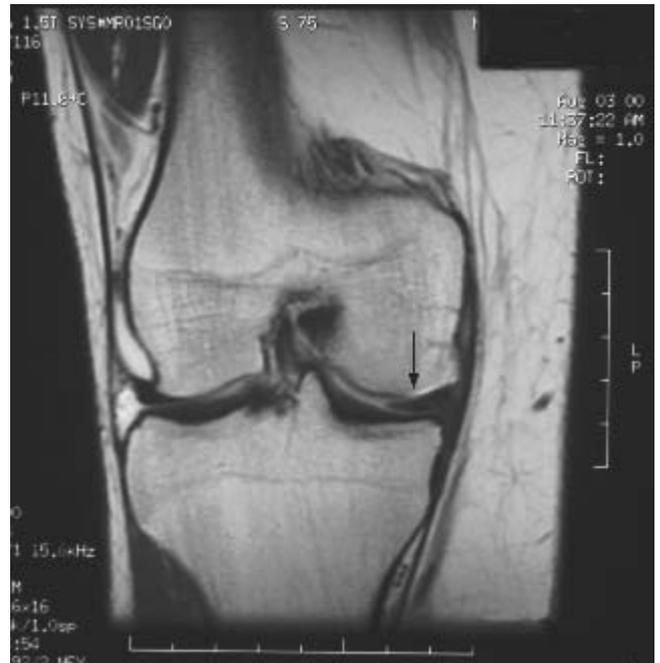
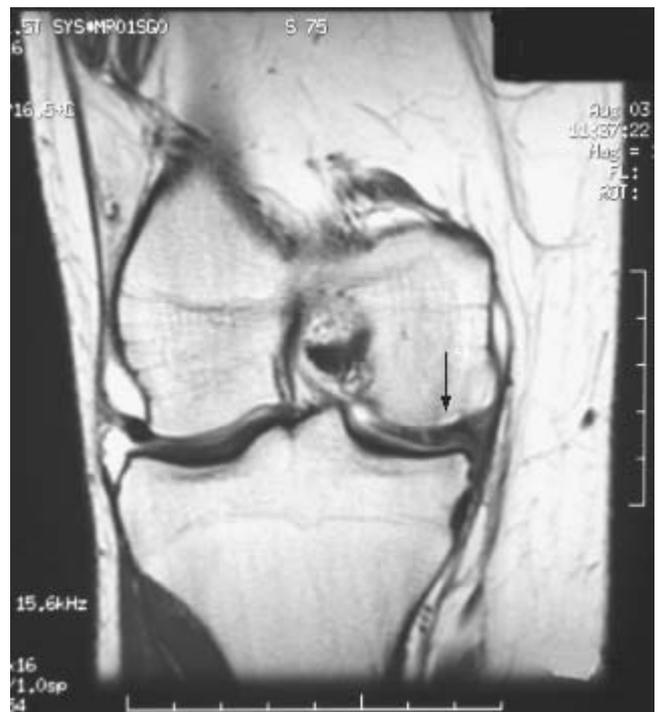
Figure 2. A narrow area of full-thickness grade IV chondromalacia over the medial aspect of the medial femoral condyle (arrows) was demonstrated on the MRI scan (2 coronal views, right knee).

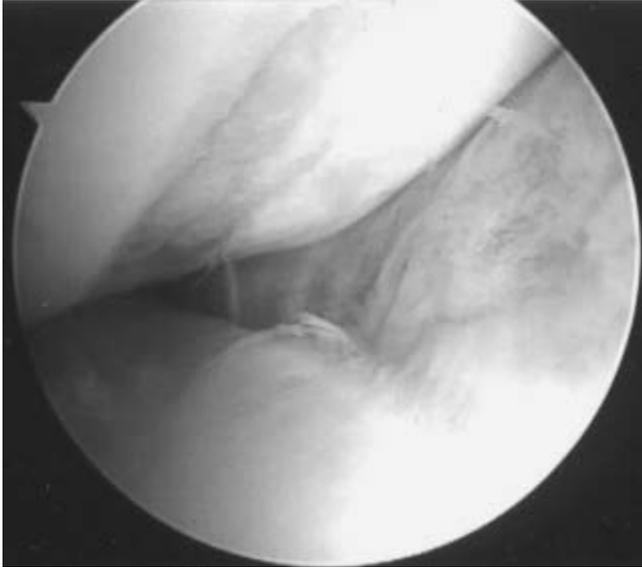
Figure 3. Arthroscopic appearance of the articular cartilage of the medial compartment of the patient's right knee. A full-thickness sagittal plane groove of grade IV chondromalacia caused by a bioabsorbable meniscal repair device is demonstrated.

The patient was brought to the operating room for an arthroscopic examination of his painful right knee. At that time, a significant groove of the articular cartilage on the medial aspect of the medial femoral condyle was noted that was caused by a meniscal arrow. On flexion and extension of the knee, the groove extended from almost near extension to full flexion. The articular cartilage defect was noted to be several millimeters wide and extended down to subchondral bone (Figure 3). The majority of the meniscal tear appeared to have healed except for a small portion of the medial aspect of the patient's medial meniscus, so an arthroscopic partial medial meniscectomy was performed. The meniscal device fragmented into shards when palpated with a probe and was removed by suction concurrent with the meniscectomy. There was no synovitis or damage to the ligamentous structures or other articular cartilage found during the procedure, and the articular cartilage of the medial tibial plateau appeared normal.

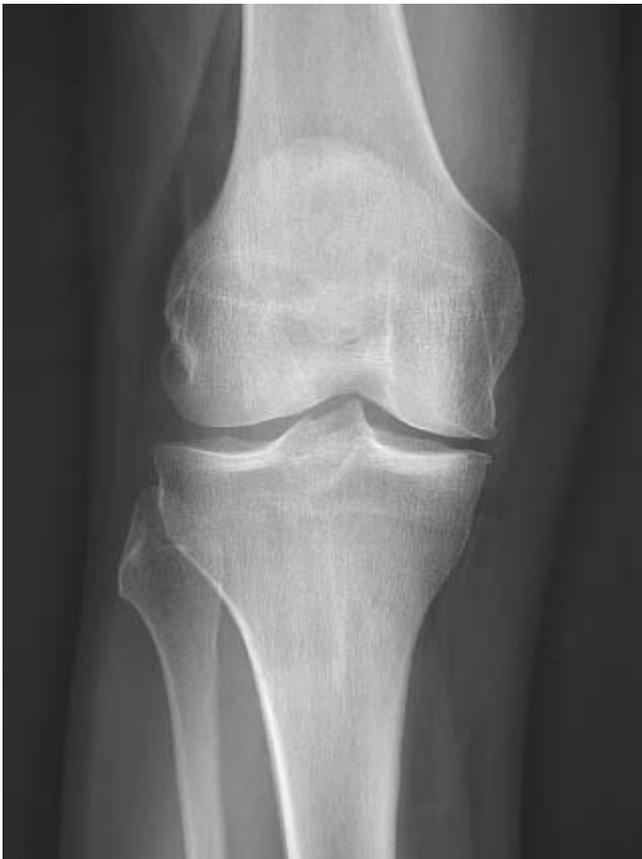
Figure 4. AP standing radiograph of the right knee 2 years after arthroscopic assessment. Osteophyte formation and joint space narrowing are seen in the medial compartment.

right knee revealed evidence of early onset osteoarthritis (Figure 4) with osteophyte formation in the medial joint line, subchondral sclerosis of the medial tibial plateau, and medial compartment joint space narrowing. Standing long-leg radiographs revealed a weightbearing axis that passed through the medial aspect of the medial tibial spine (Figure 5). A repeat MRI scan revealed further progression of his medial compartment articular cartilage changes. The corresponding medial tibial plateau articular cartilage was worn down to subchondral bone (Figure 6). The patient was placed into a custom-made right knee medial compartment unloader brace and has noted a moderate amount of improvement in his functional limitations with the use of the unloader brace.

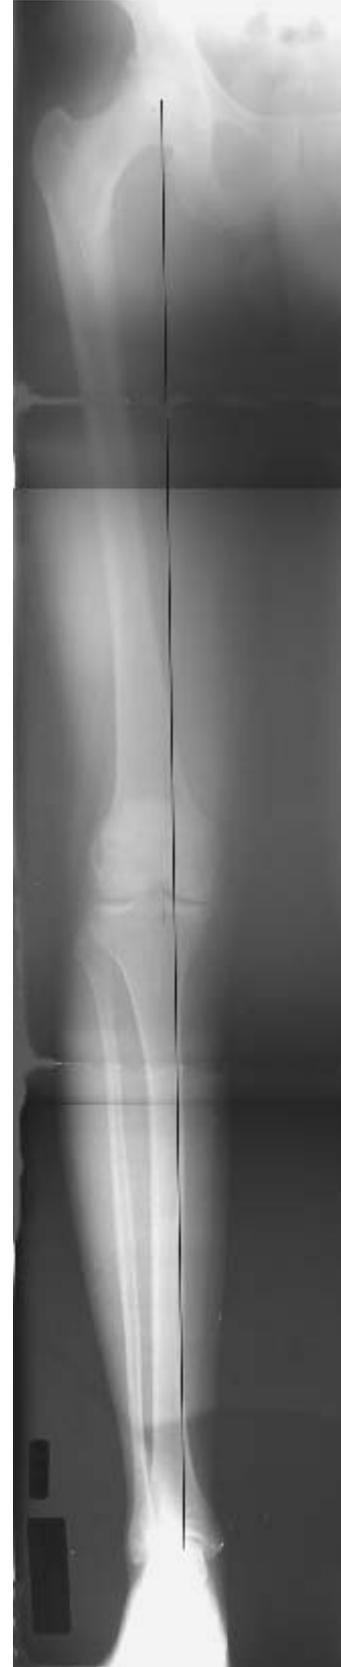
Figure 5. Long-leg AP alignment radiograph showing the mechanical axis passing through the medial aspect of the medial tibial spine.

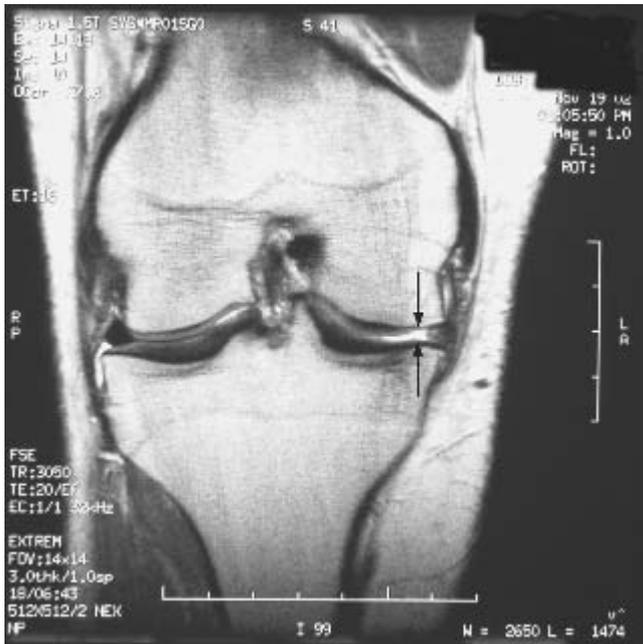
Figure 6. A repeat MRI scan demonstrates full-thickness chondral kissing lesions of the far medial aspect of the medial compartment (coronal view, right knee, 2 years after arthroscopic assessment).
